# Technical Service Information

## MERCEDES 722.3 - 722.4 SLIPPING AND/OR NO REVERSE

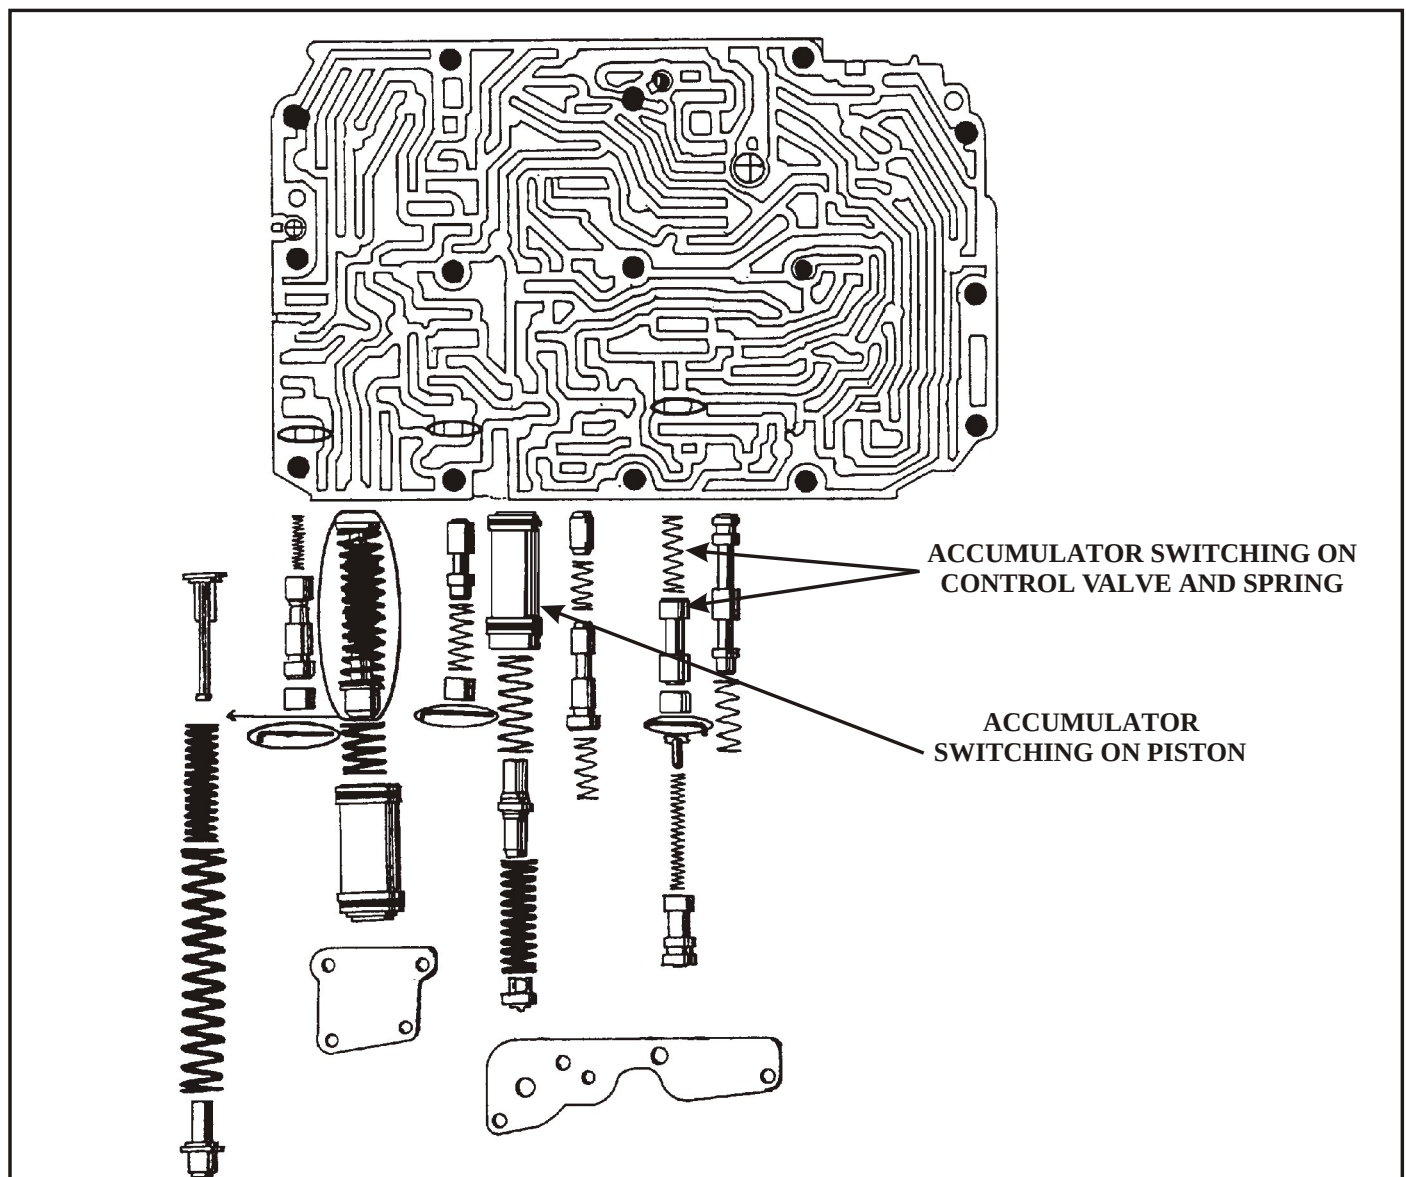
Figure 1

**COMPLAINT:** Before and/or after rebuild, any Mercedes equipped with the 722.3 - 722.4 transmission may exhibit a chattering in reverse, slipping in reverse, or no reverse.

**CAUSE:** The cause may be, a stuck or sticking *Accumulator Switching On Control Valve*, a collapsed or broken *Accumulator Switching On Control Valve Spring*, a missing, cut, or leaking seal ring on the accumulator piston, or a cracked *Accumulator Switching On Piston* (See Figure 1).

**CORRECTION:** Remove and disassemble the valve body. Inspect and replace as necessary, the parts and concerns listed above, as shown in Figure 1.
